Case 362 : Narrative

Case Vehicle (A): 1998 Chevrolet
Type: Venture, Sport van
Driver: 35-year-old female
CDC: 12-FZEW-4

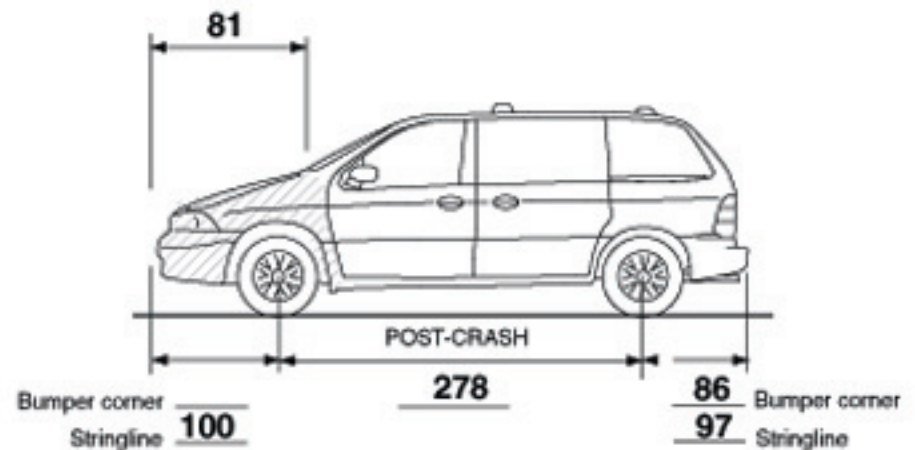
Max. crush to
right-front
bumper corner

Width of direct damage
to front

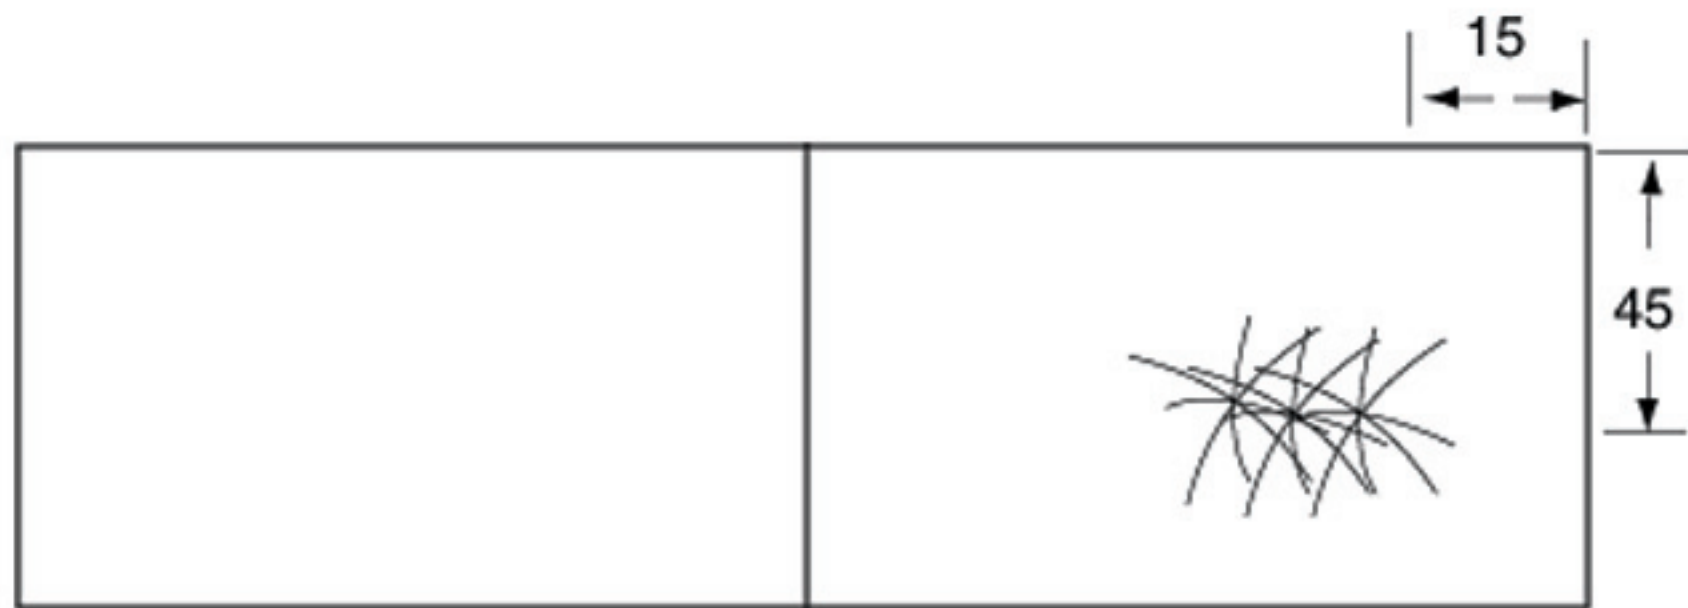
**Windshield cracked on right by passenger airbag and
airbag cover contact**

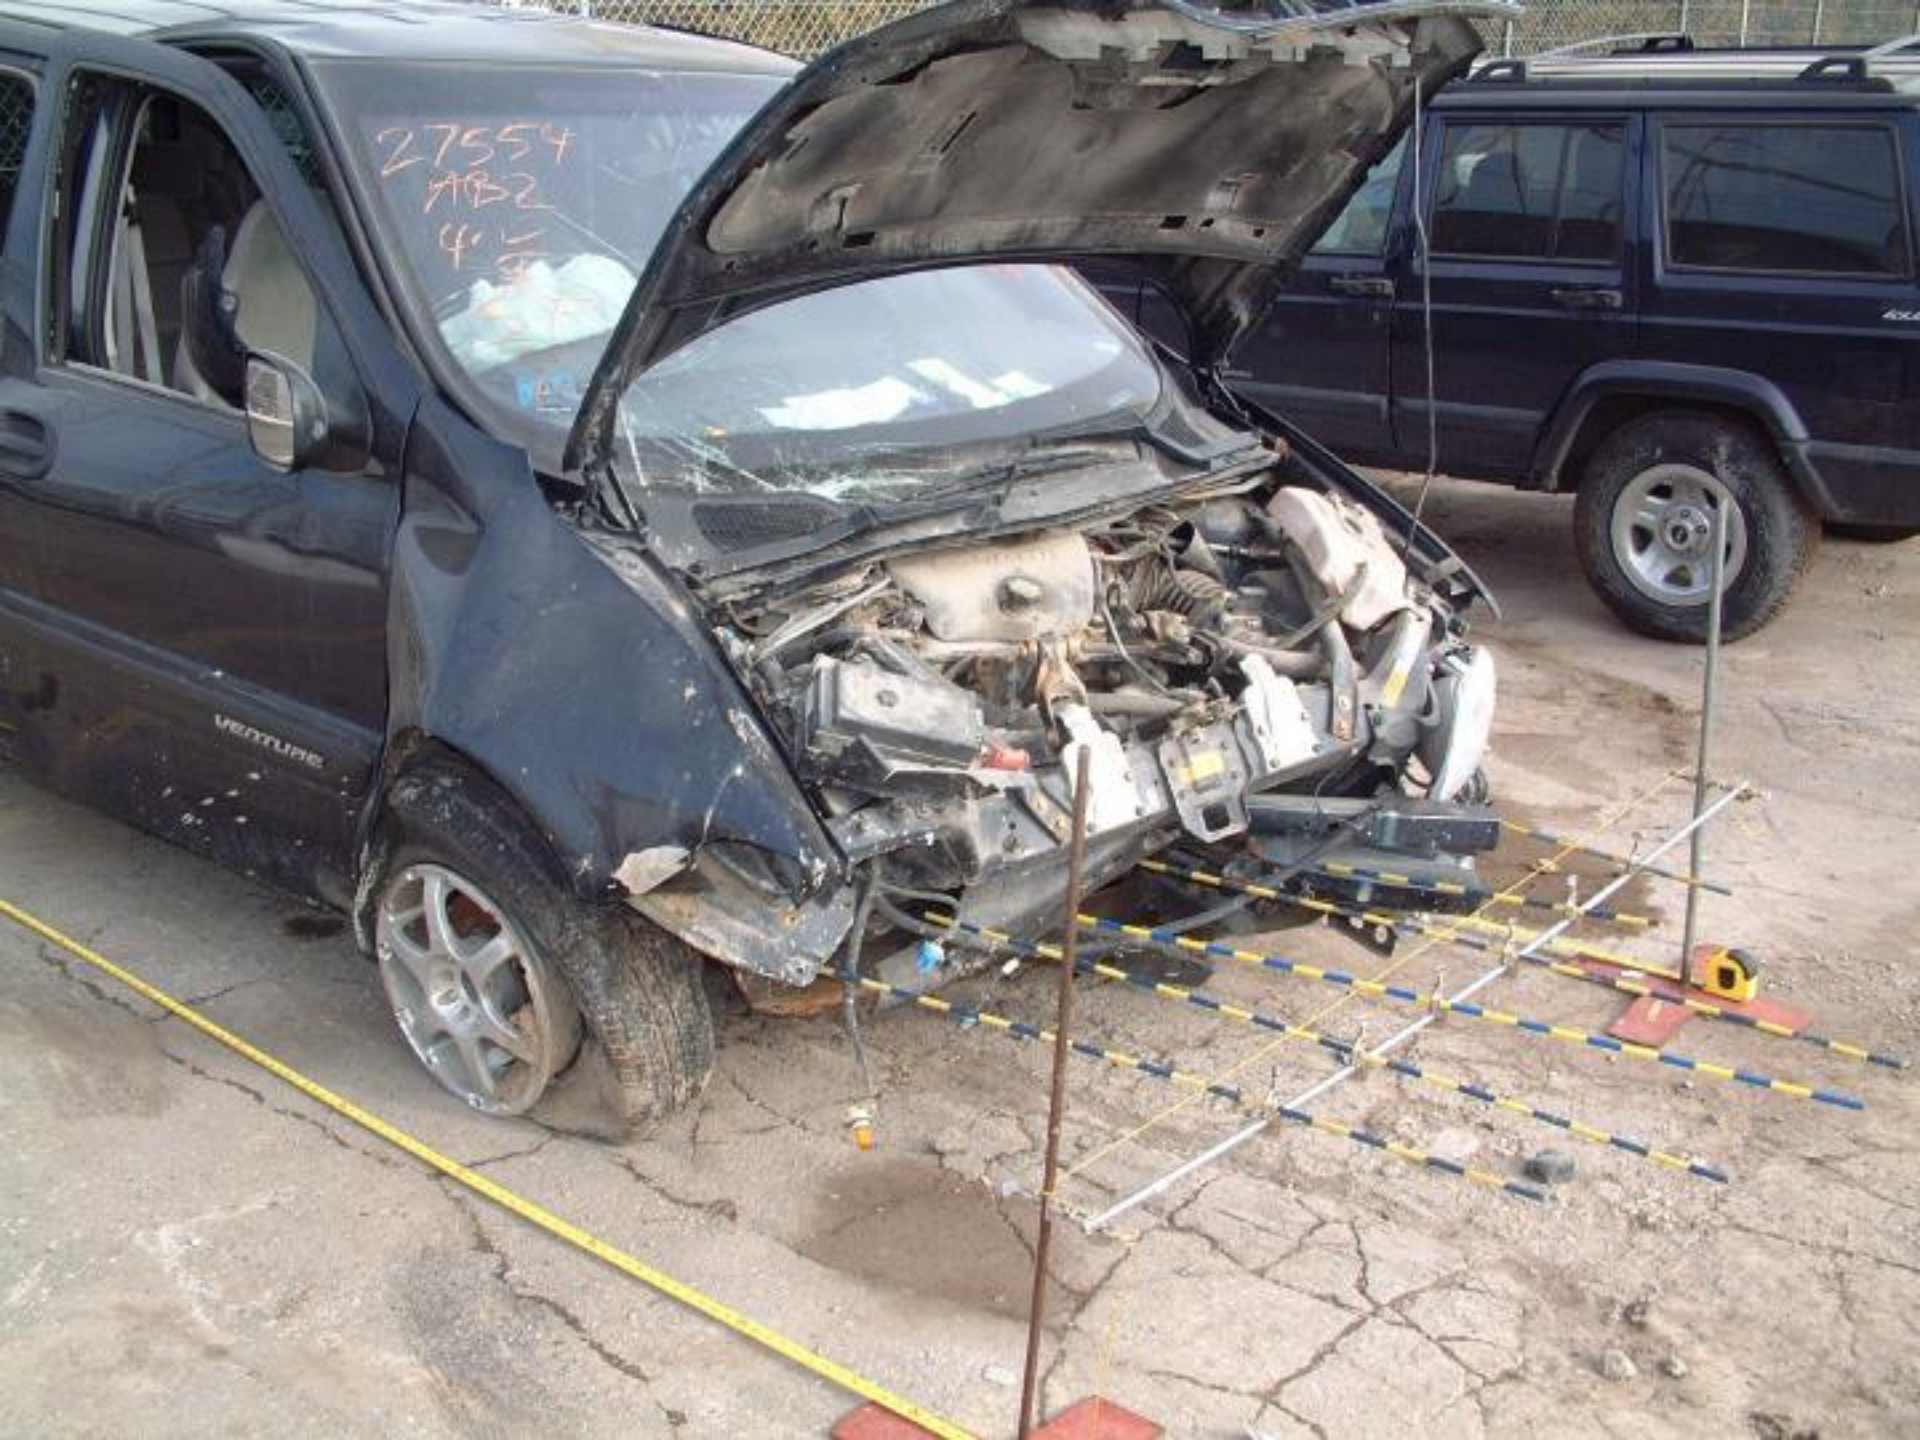
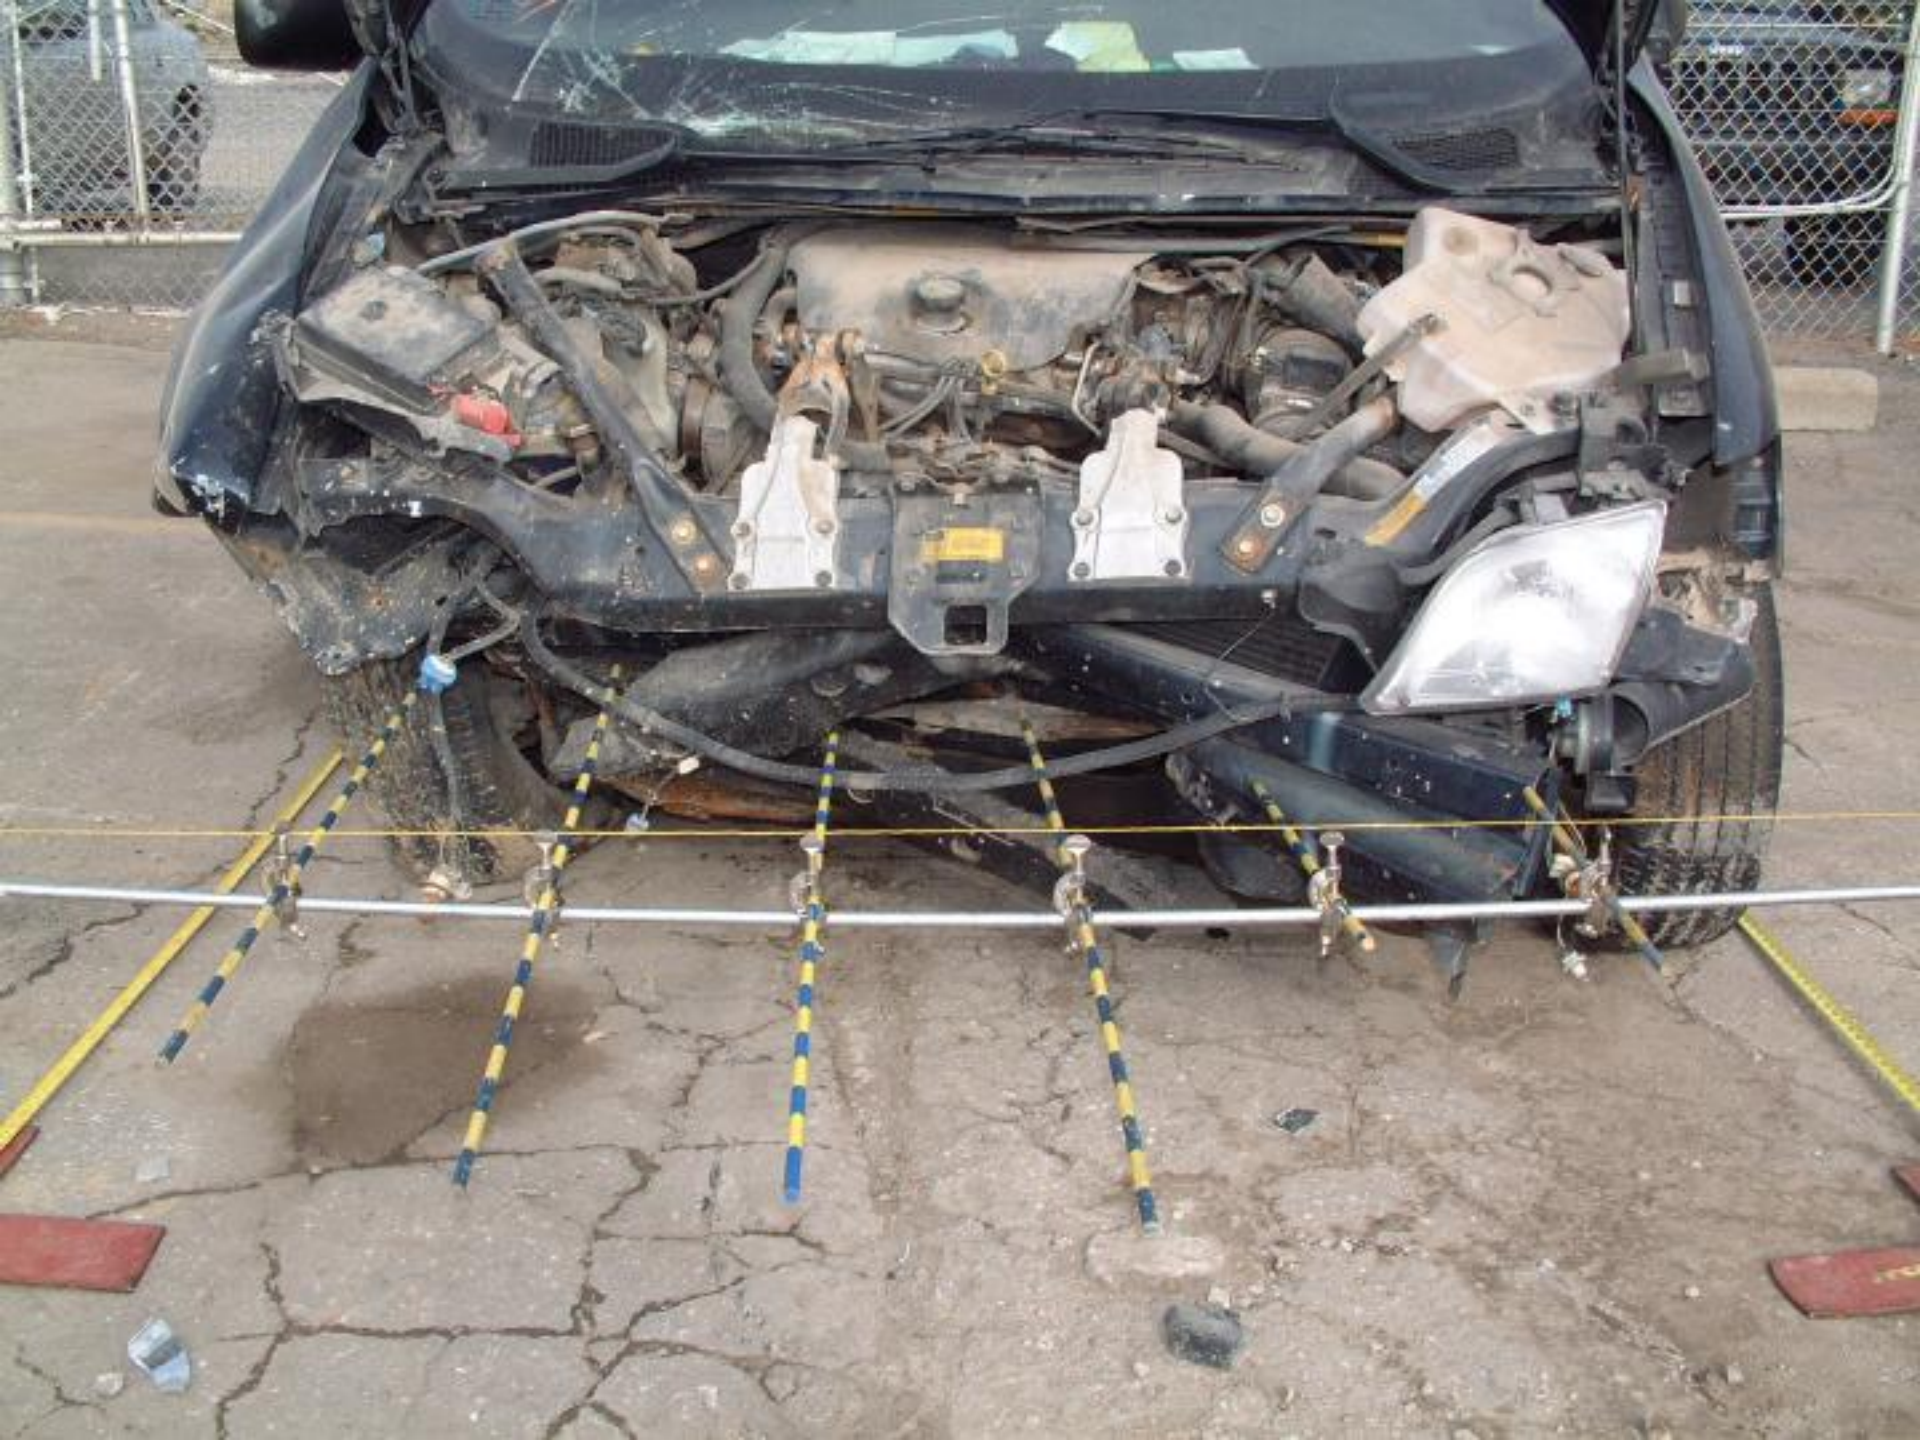
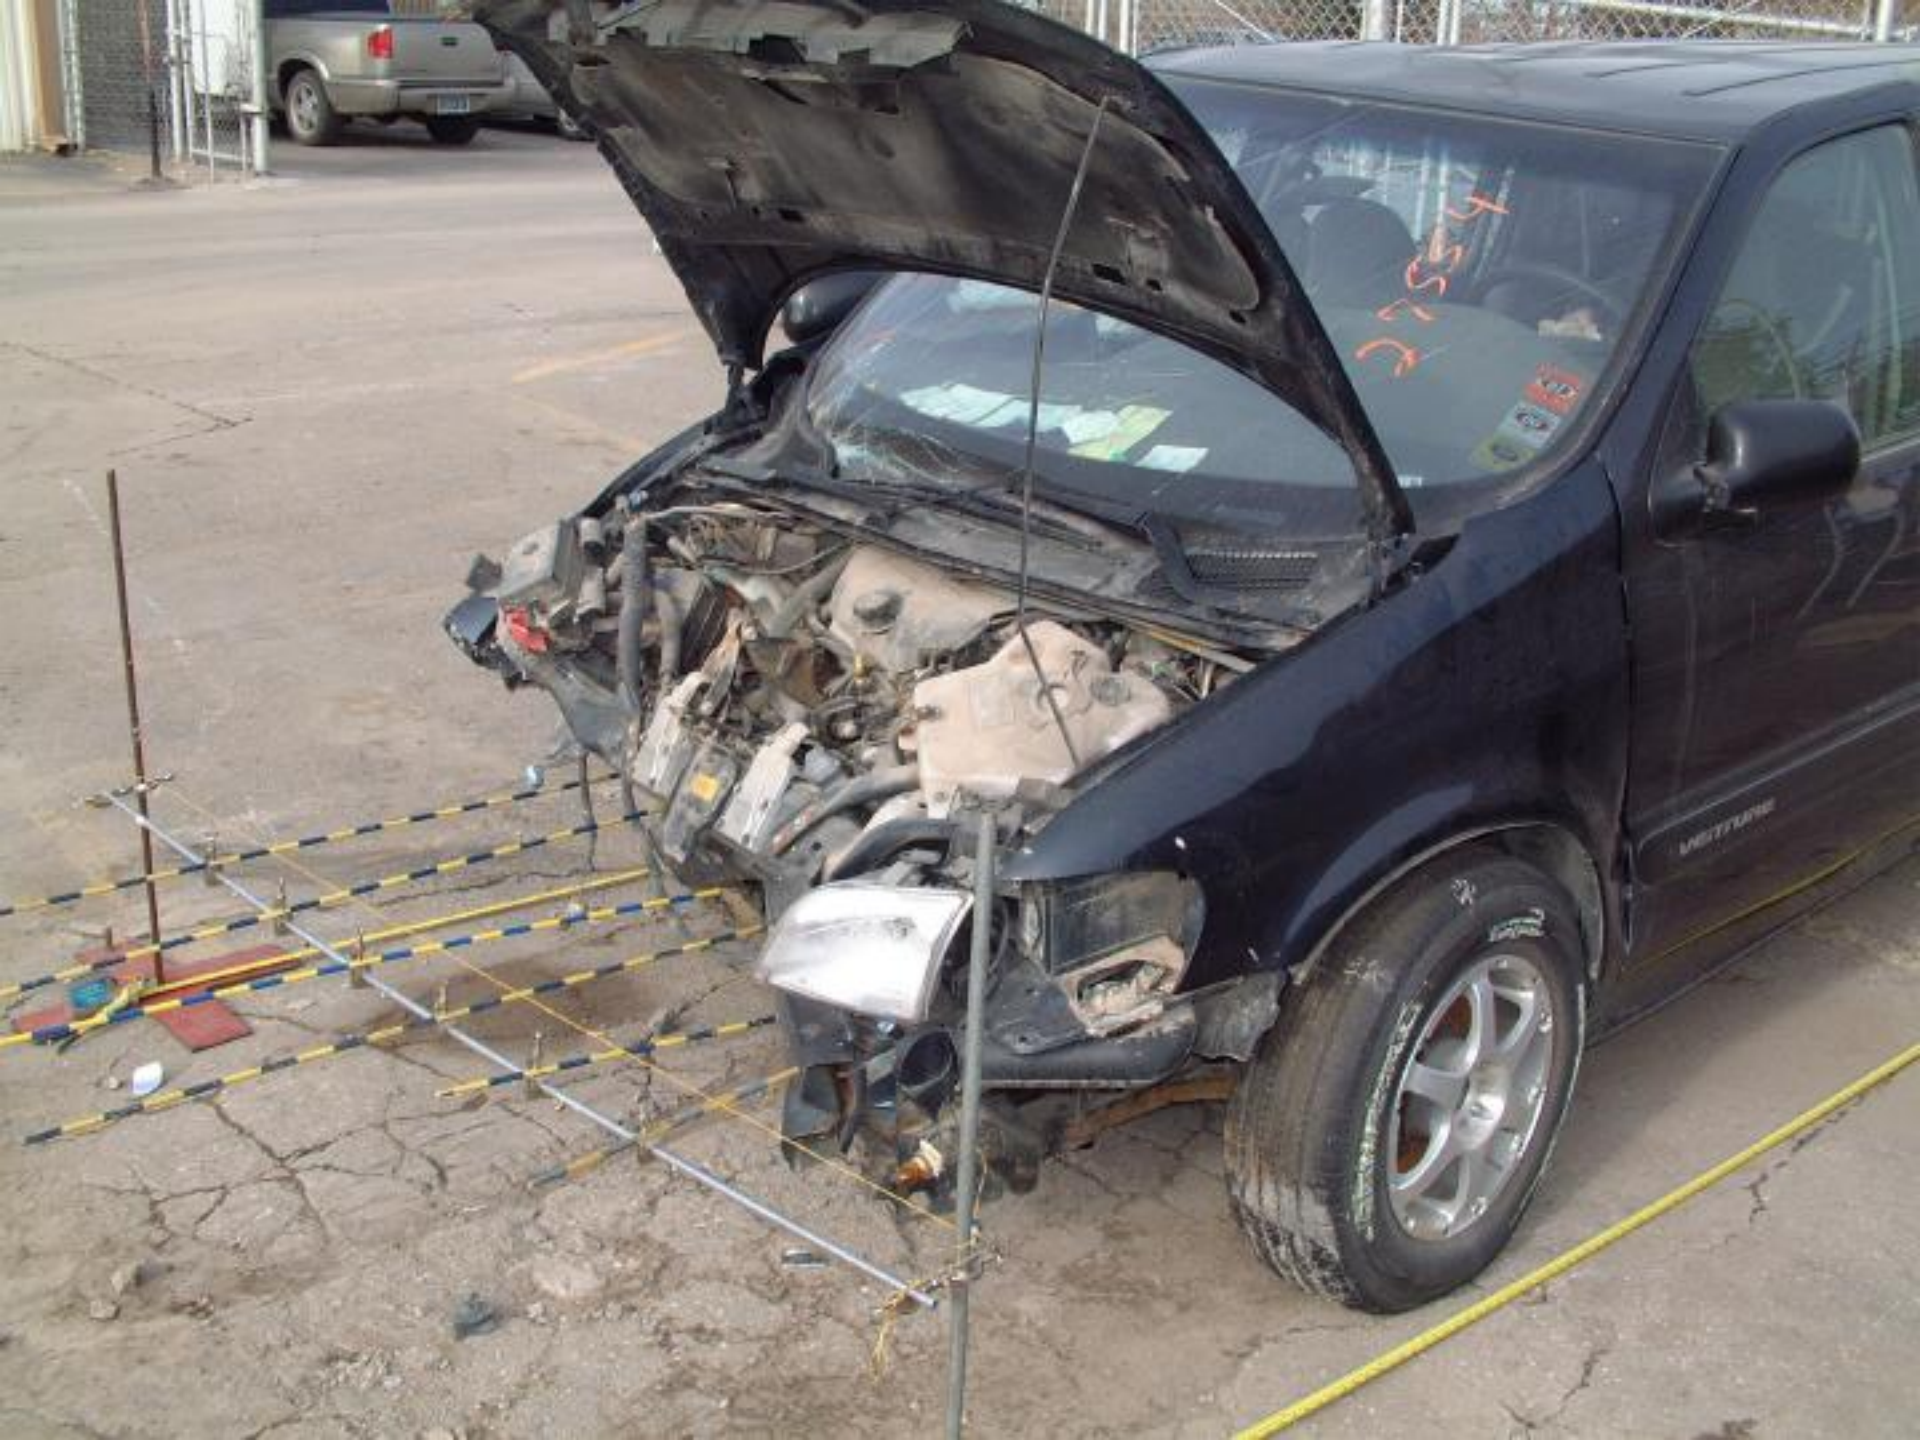
[23 24](#) On the right side, the fender, the upper and lower sections of the A-pillar, and the right-front wheel were crushed rearward, reducing the wheelbase by 22 cm. The right-front tire was flat, [25](#) the roof above the B-pillar was buckled, [26 27](#) the right-front door was jammed closed, and the two forward windows were broken out. The right-rear door was undamaged and operational, and the rear right-side glazing was intact.

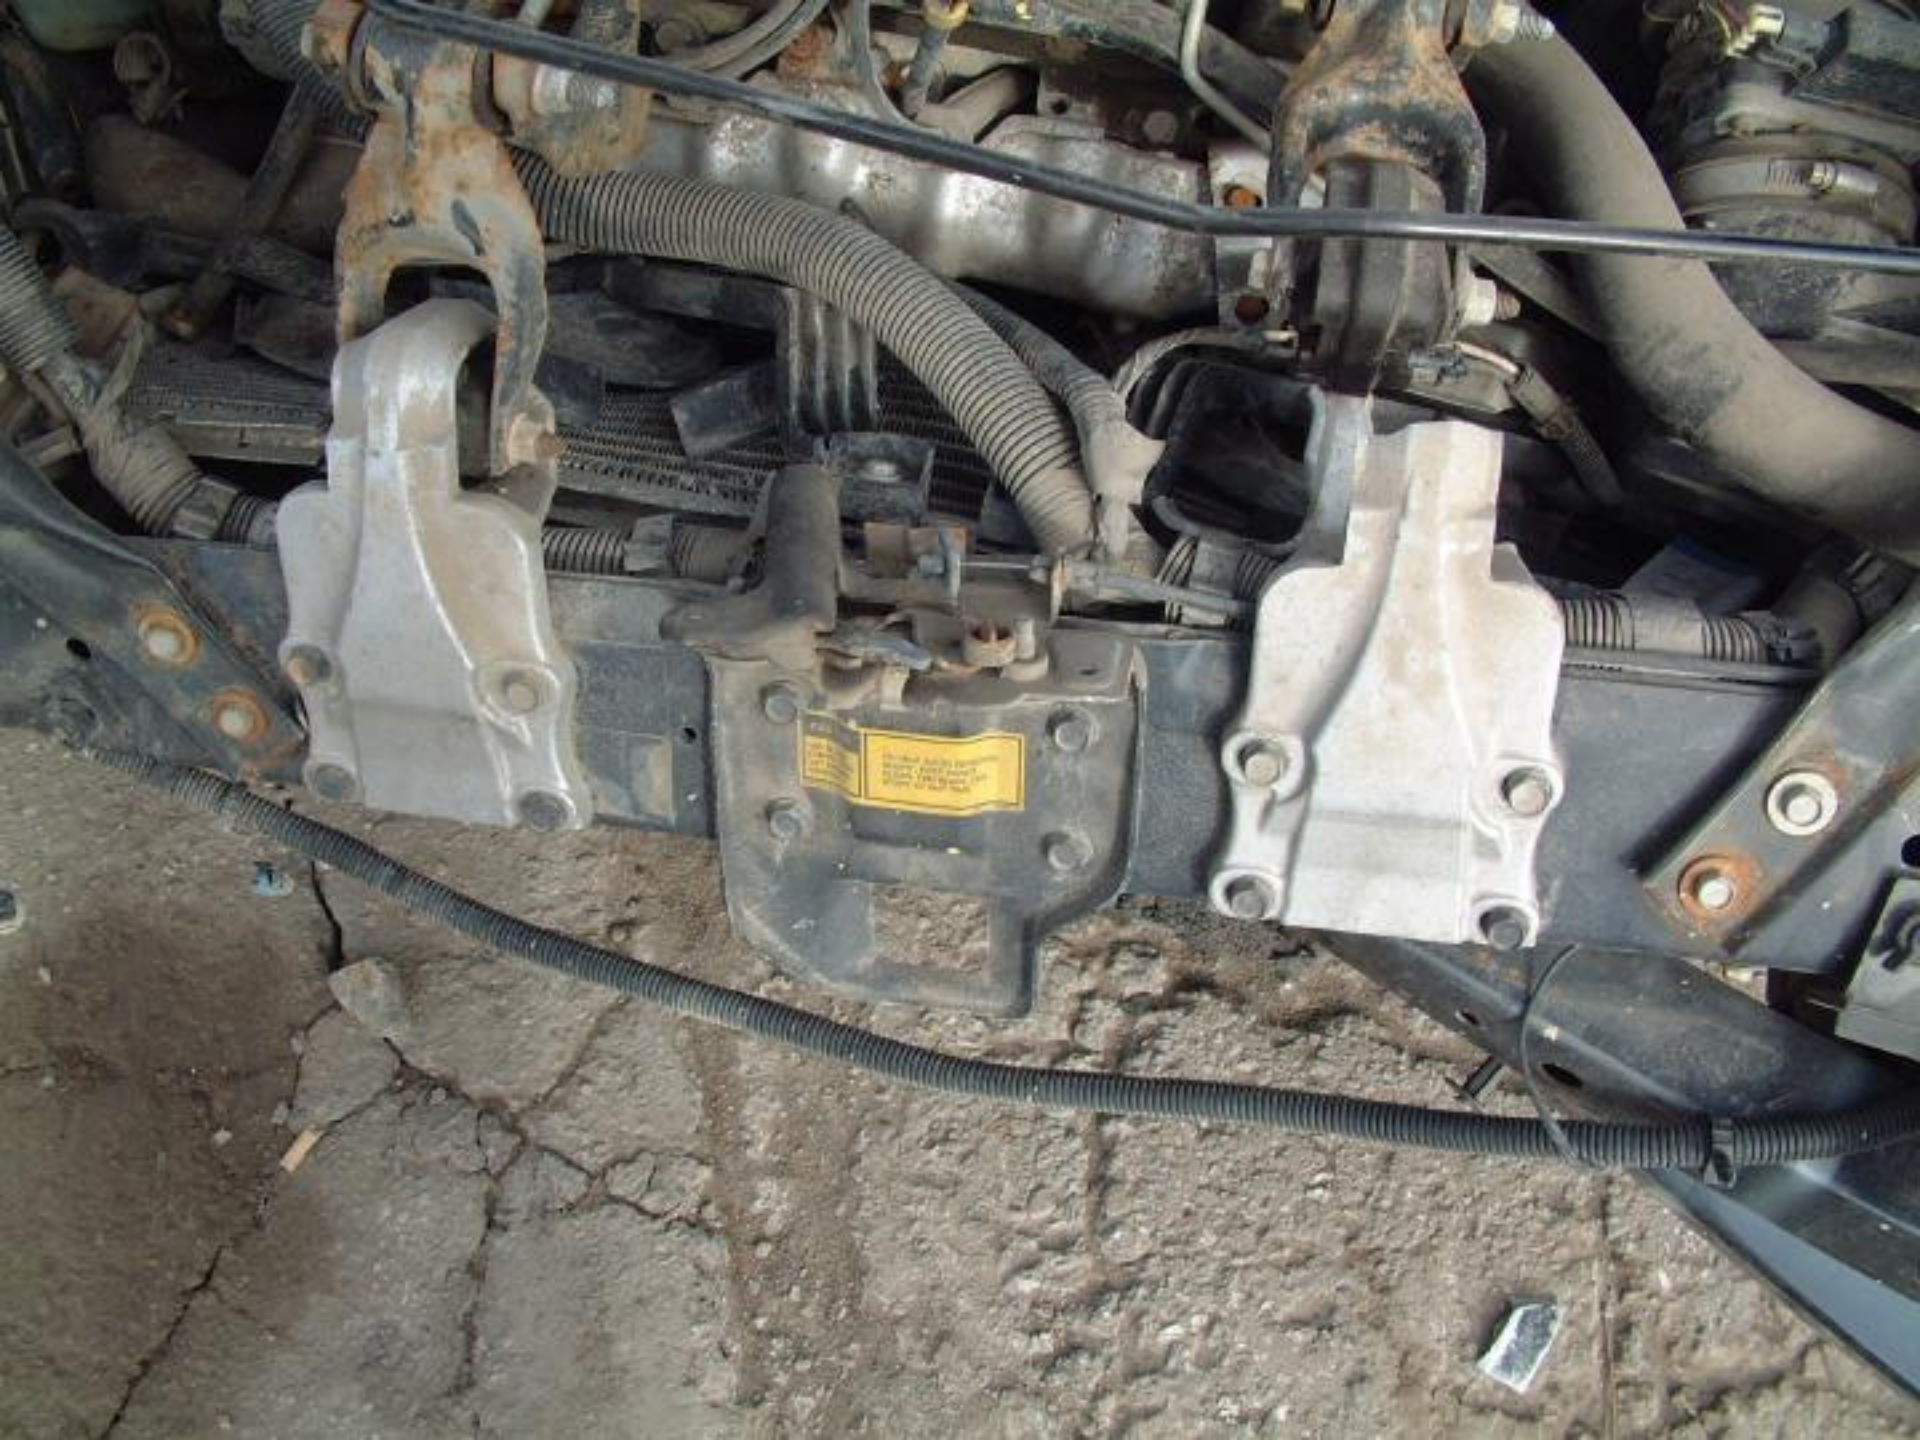
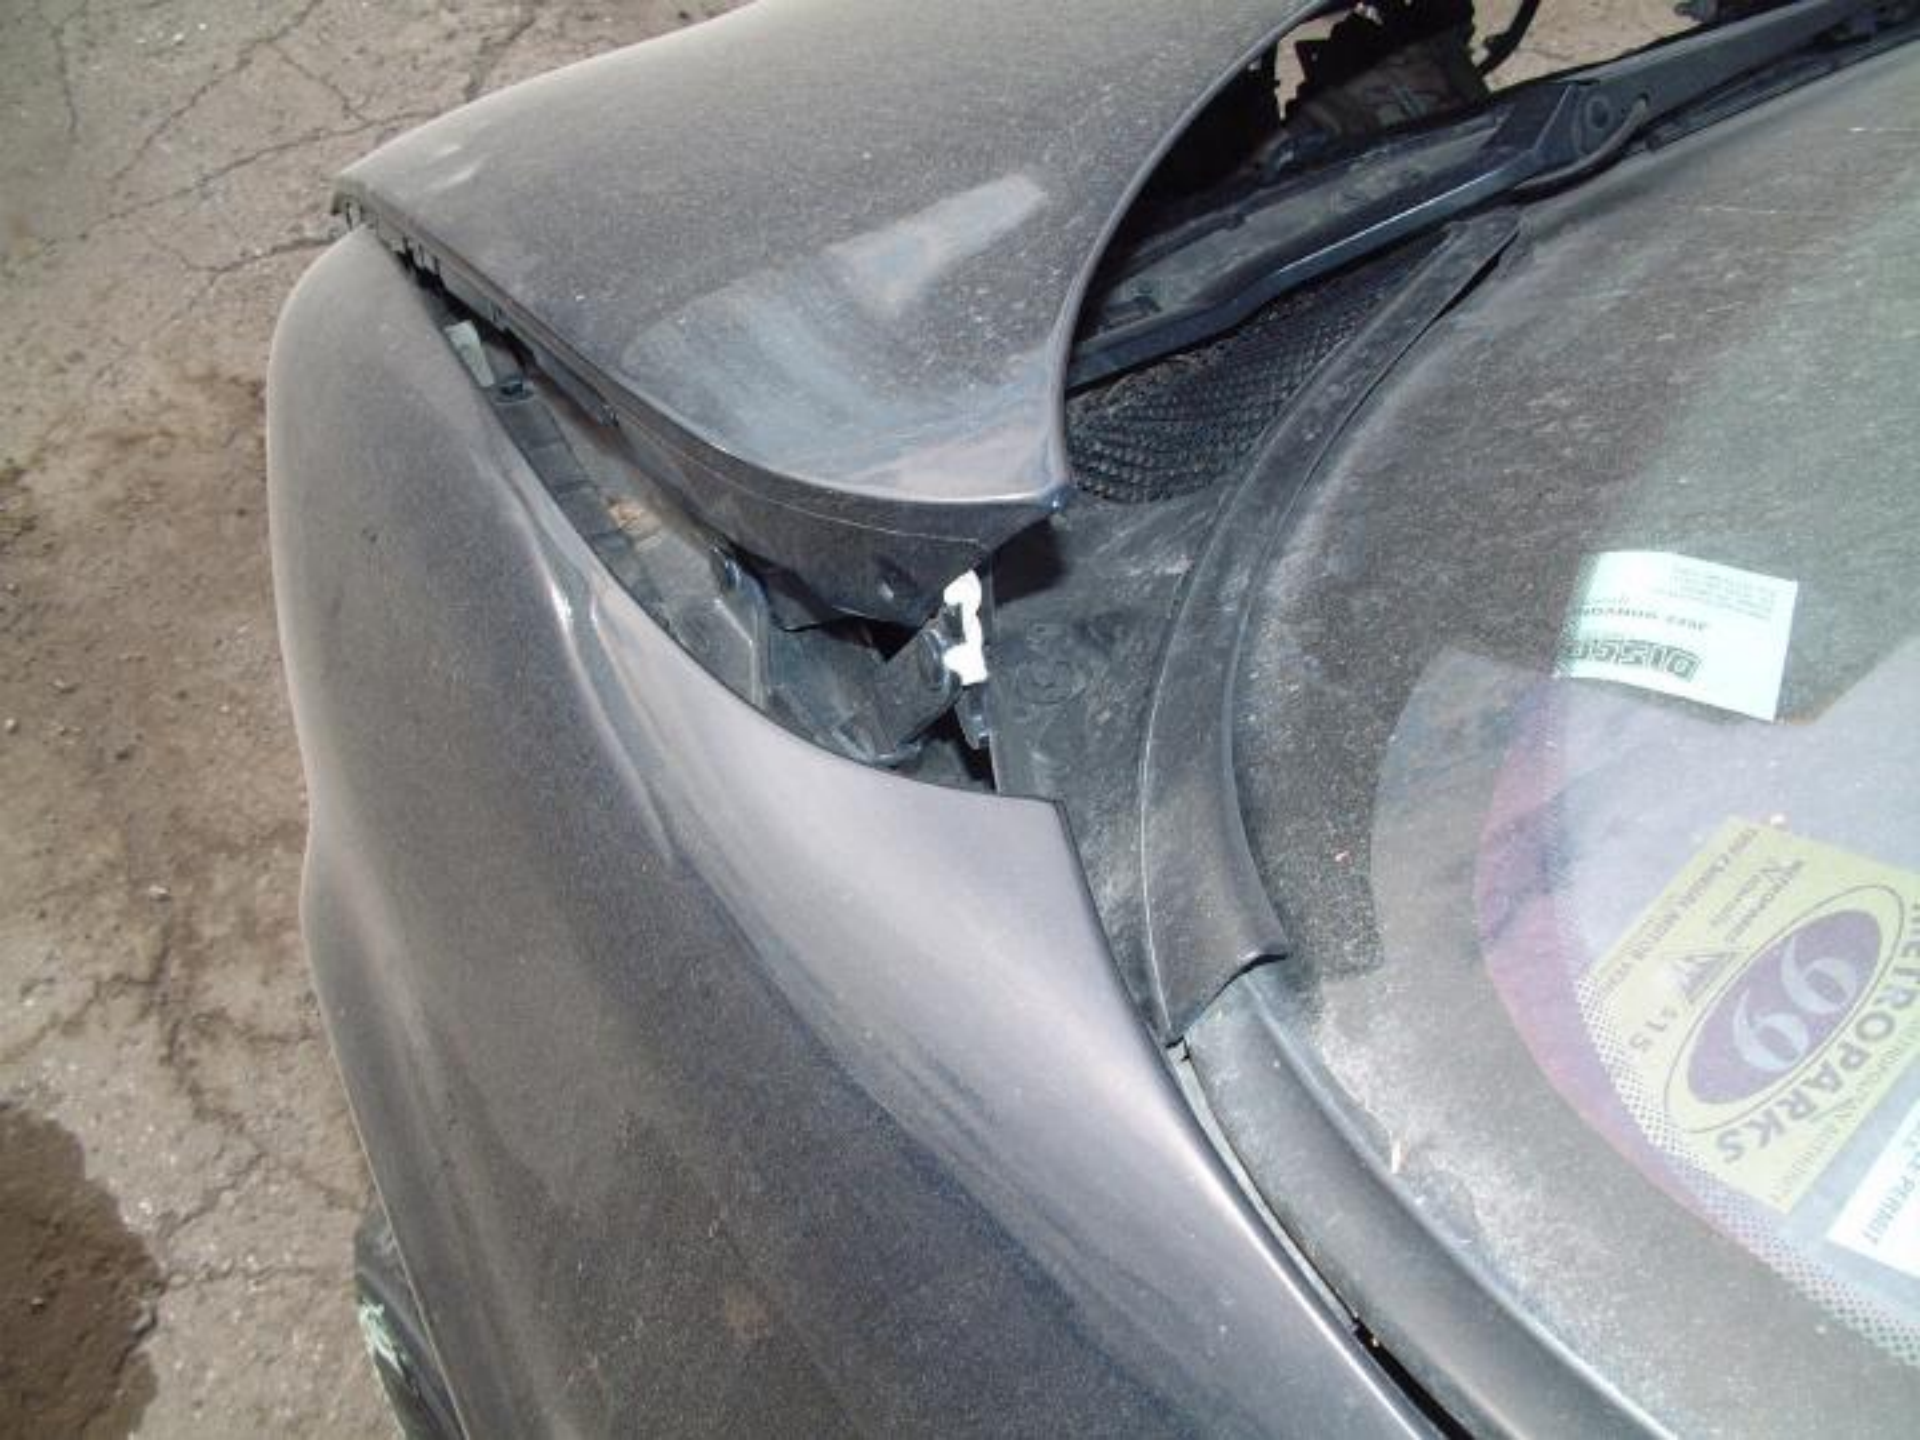
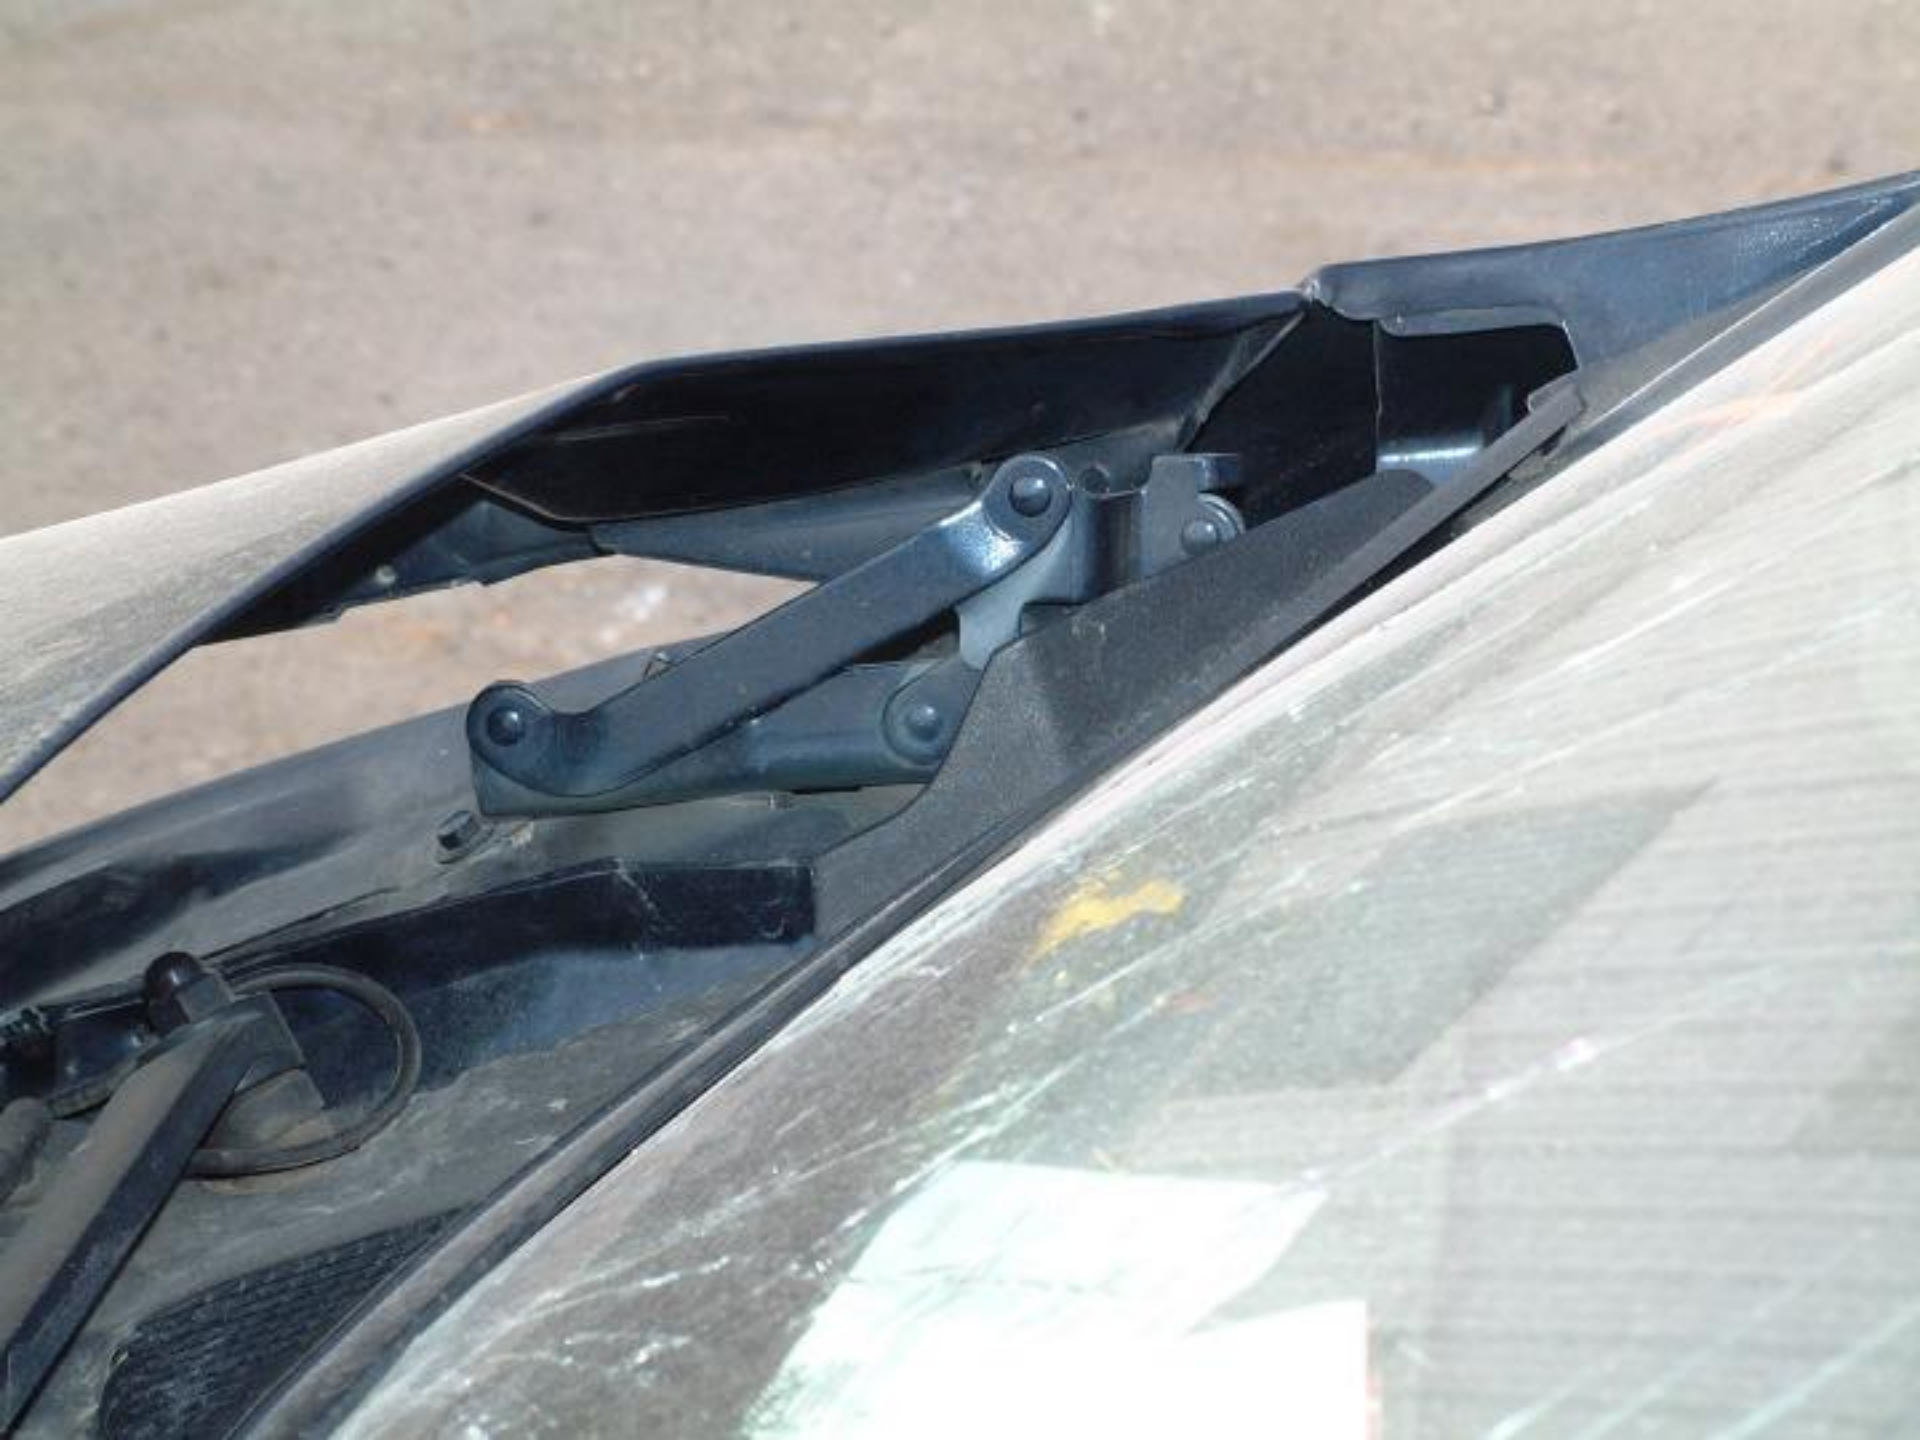
[30](#) [31](#) On the left side, the front fender was displaced to the rear. The left-side door was undamaged and operational and the left-side glazing was intact. The left wheelbase was reduced by 7 cm.
